Memo

**To: Bob Schaefer, P.E., Asst. Dir. of P.W.****Date: March 26, 1998****From: Randy Lyman, Pretreatment Coordinator****Re: Closed Burger Station Inspections 3/25-26/1998 you requested.****CC: Ed Malter, Pretreatment Inspectors, Food Inspection(Health)**2456 N. Kansas Expressway

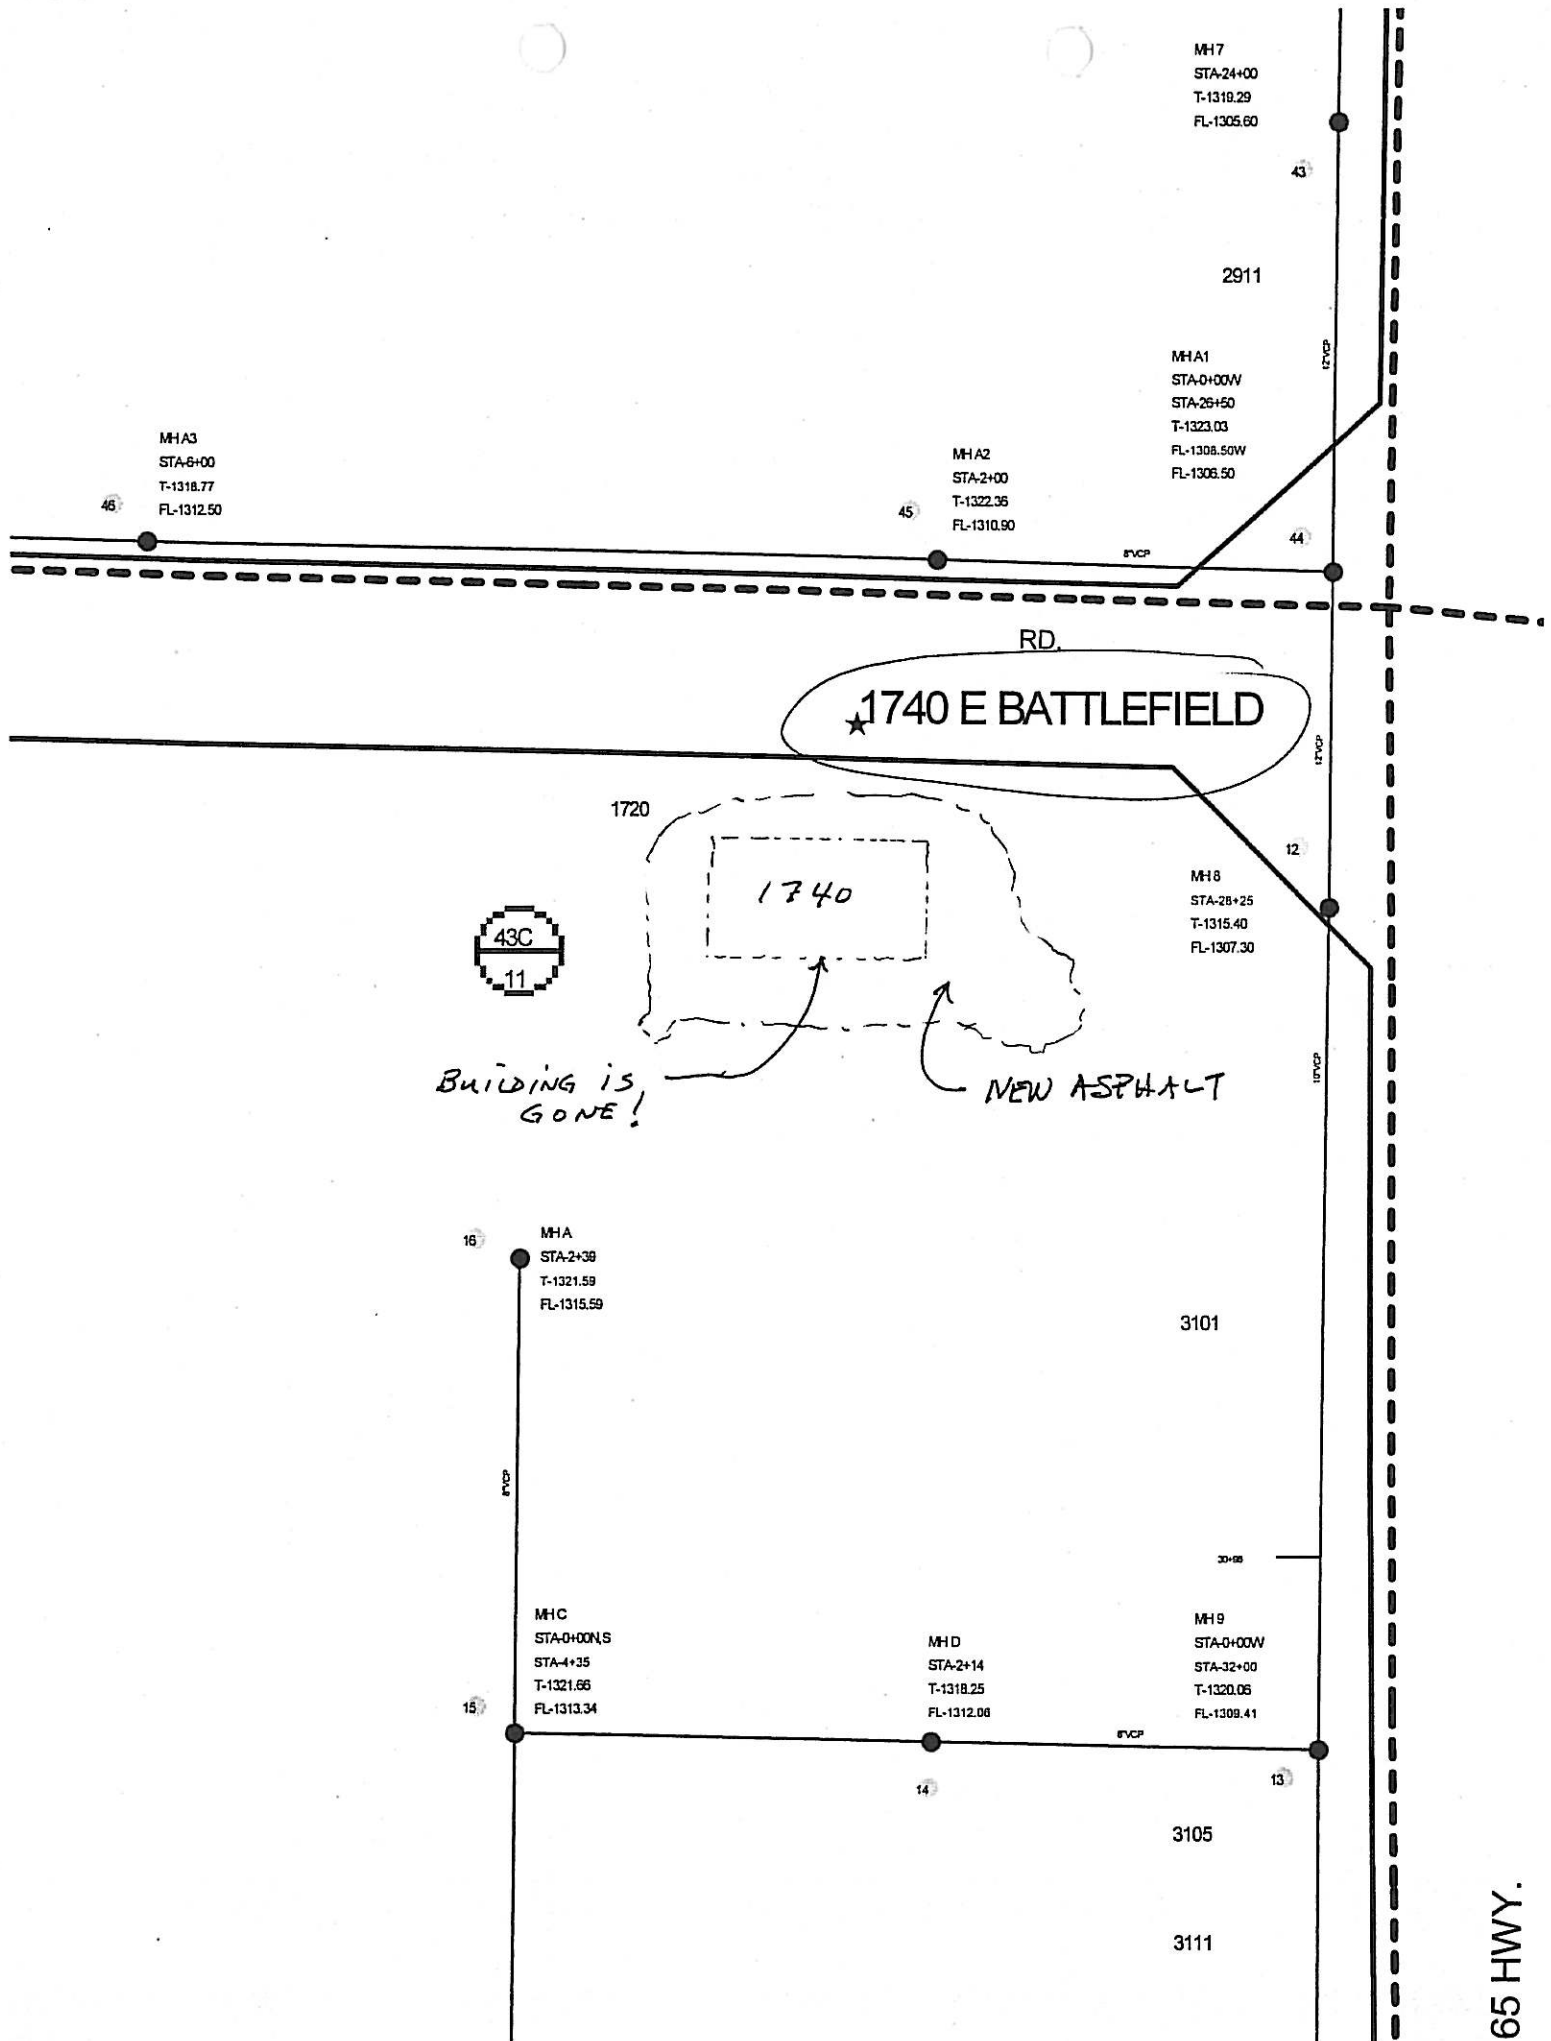
S. CAMPBELL

Closed. Sampling manhole present, no apparent seal between wall and floor, invert shelves full of dirt, no ram-nek visible under ring and lid casting. Pipe has been sawed out to allow sampling. No grease noticeable in sampling manhole. No outside grease trap. Building was locked and all fixtures removed. By looking through the window it appears to have a 20(?) pound grease trap in the floor where the 3-vat sink used to be. Had a Crouch type casting. No sign of grease in City sewer downstream from connection.

SAMPLING M.H.

GREASE TRAP
